### **Village of Olympia Fields**

### **Red Light Running Camera System Follow-up Evaluation Report for Year 2010, 2011, 2012**

#### **Intersection of Lincoln Highway (US 30) at Governors Highway/Crawford Avenue**

#### **(Westbound Approach in Olympia Fields)**

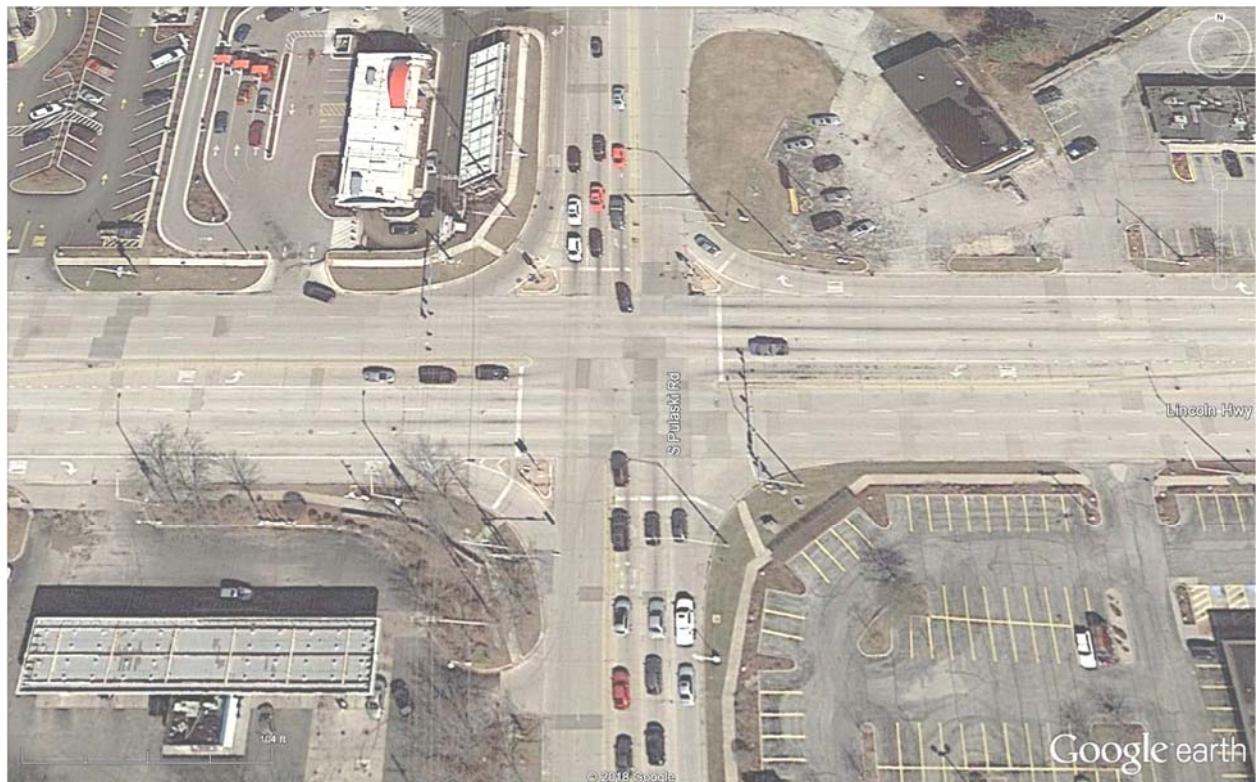
**Lincoln Highway (US 30) at Governors Highway/Crawford Avenue - Exhibit 5**

The northwest, southwest, and southeast quadrants of the intersection are occupied by shopping centers, restaurants, gas station, and a car washing facility. The northeast quadrant has an auto service facility, restaurant as well as residential area further east and northeast of the intersection. The land use adjacent to the intersection is summarized by quadrants:
