Village of Olympia Fields

Red Light Running Camera System Follow-up Evaluation Report for Year 2013, 2014, 2015

Intersection of Lincoln Highway (US 30) at Governors Highway/Crawford Avenue

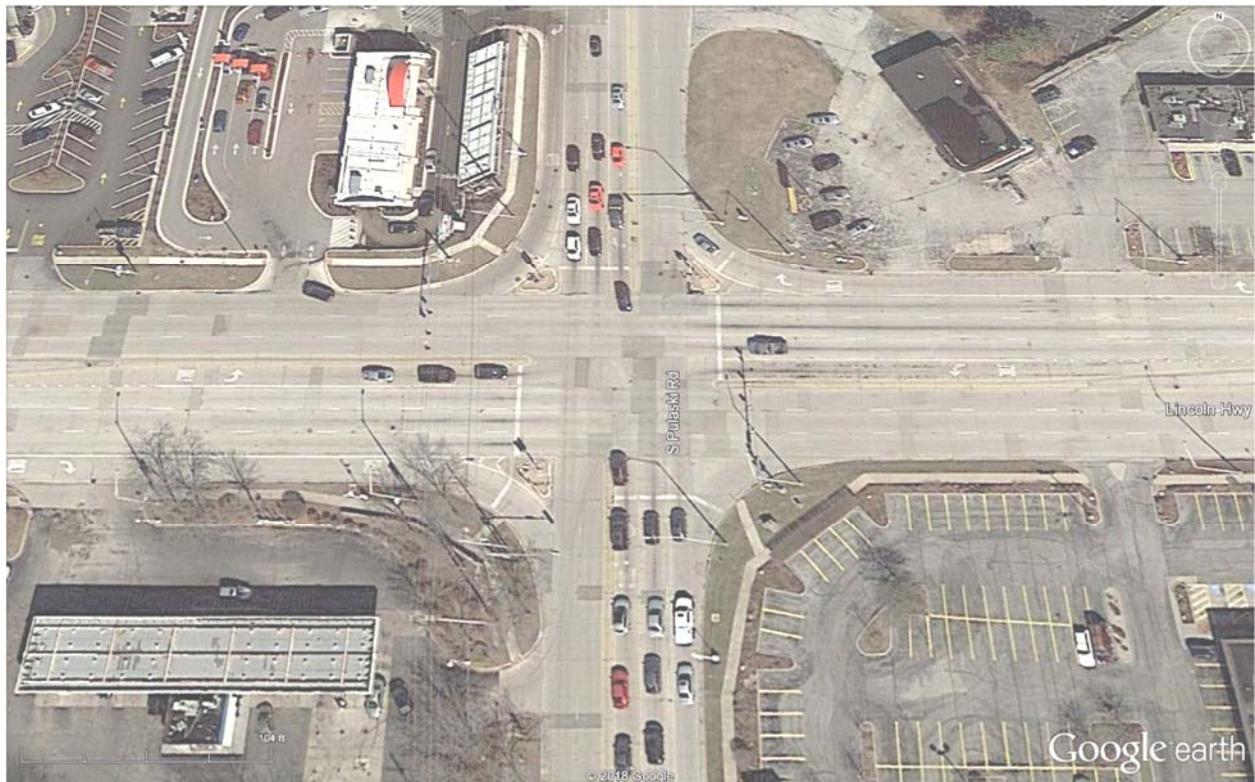
Lincoln Highway (US 30) at Governors Highway/Crawford Avenue - Exhibit 5

The northwest, southwest, and southeast quadrants of the intersection are occupied by shopping centers, restaurants, gas station, and a car washing facility. The northeast quadrant has an auto service facility, restaurant as well as residential area further east and northeast of the intersection. The land use adjacent to the intersection is summarized by quadrants:

1. Northwest – Car wash, shopping center, restaurants
2. Northeast – Auto service, restaurant and retail, residential

3. Southwest – Gas station, Matteson Plaza shopping center
4. Southeast – Restaurants, retail, medical office space

Updated pictures of the intersection are shown in **Exhibits 1 thru 4**, and the aerial photo provided by Google Maps is shown in **Exhibit 5**.
